UNITED STATES AIR FORCE
AIRCRAFT ACCIDENT INVESTIGATION
BOARD REPORT

F-35A, T/N 10-5015

58TH FIGHTER SQUADRON
33D FIGHTER WING
EGLIN AIR FORCE BASE, FLORIDA

DATE OF ACCIDENT: 23 JUNE 2014

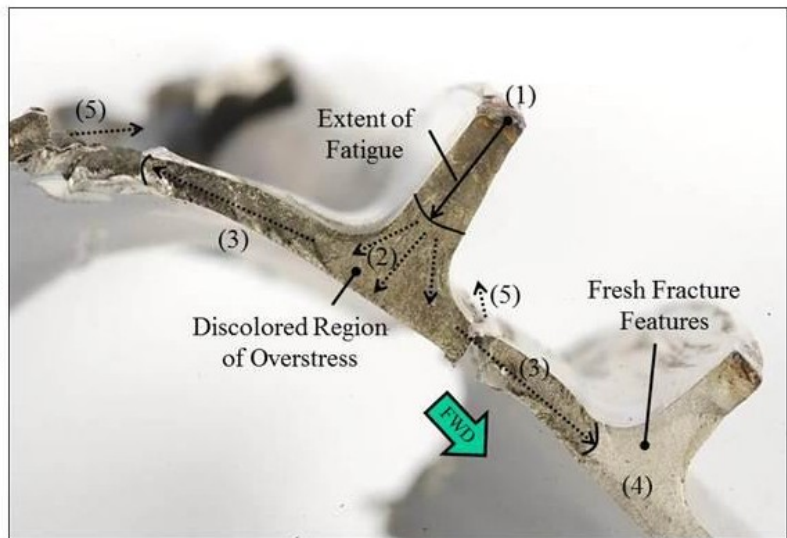
Fig-3. View of Plate Seals Showing Fracture Sequence (Tab J-104), repeated as Fig-22 and discussed in detail

Fig-3 shows the the fracture sequence of the mishap R3 plate seal, as analyzed by P&W (Tab J-104).

Fracture Sequence:

1. Fatigue progressed in the radial direction from the tip of the plate seal.
2. The crack continued in progressive tearing/overstress to the base of the plate seal and into the barrel of the integral arm.
3. The crack extended via progressive tearing in the axial direction forward and aft.
4. The final overstress fracture through the integral arm resulted in the loss of the hoop.
5. Circumferential overstress fractures occurred between the plate seals, and between the disk and forward integral arm.

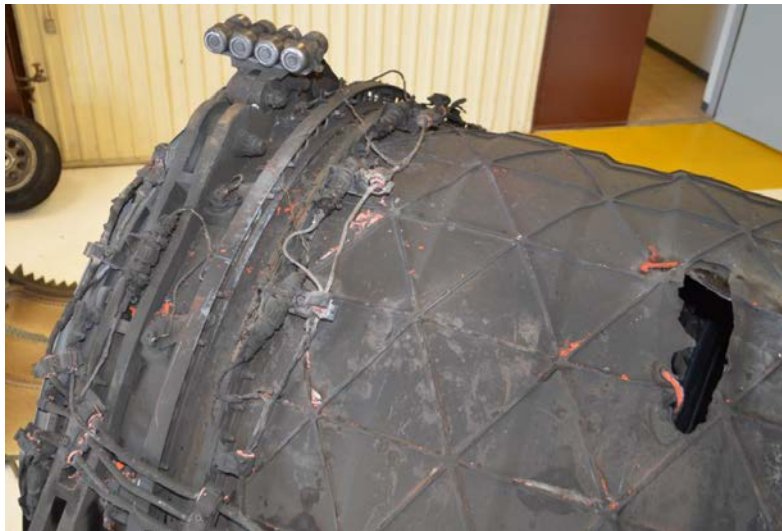
Upon disassembly, the R3 was found to be missing the entire integral arm from the IBR (Tab J-157). The pieces of the R3 integral arm appeared to have punched through the top of the engine fan case (Fig-7) and fuselage at the 11 o'clock position (aft (rear) looking forward) (Tabs S-4, S-5). The fragments consisted of two large pieces measuring roughly 5-6 feet in length (Tabs J-151 thru J-152) and multiple smaller pieces (Tab J-100). (Fig-13, Fig-14)

Fig-7. Hole in top of fan case (Tab S-4)

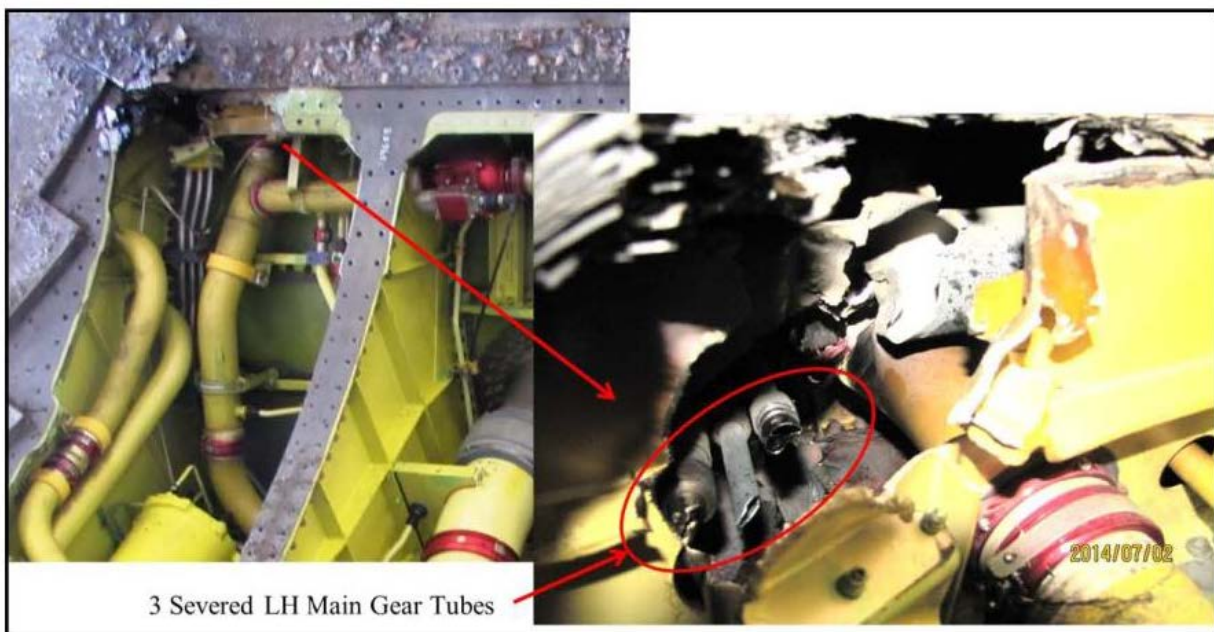
The F-35A uses hydraulic power to extend and retract the landing gear, open and close various external doors, and provide braking and steering during ground operations. The system is pressurized by an engine driven pump during normal operations. Various hydraulic lines run across and along the aircraft. (Tab J-54). During the mishap, Crash Survivable Memory Unit (CSMU) (in civilian terminology, this type of device is sometimes referred to as a “black box”) data indicated hydraulic system B experienced a rapid loss of fluid immediately following the engine stall (Tabs J-56, J-57). Technical experts at Lockheed Martin, P&W and the JPO believe this occurred when the R3 integral arm pieces severed three hydraulic lines (Fig-8)(Tabs J-9, J-147 thru J-148, J-152). Within 17 seconds of the lines being cut, the CSMU data showed the B system hydraulic reservoir was empty (Tabs J-56, J-57). However, hydraulic system A functioned normally to provide redundant power to the wheel brakes as the MP brought the aircraft to a stop (Tabs J-69 thru J-71, V-2.5).

Fig-8. Hydraulic and fuel line damage at fragment exit point (pg J-61)

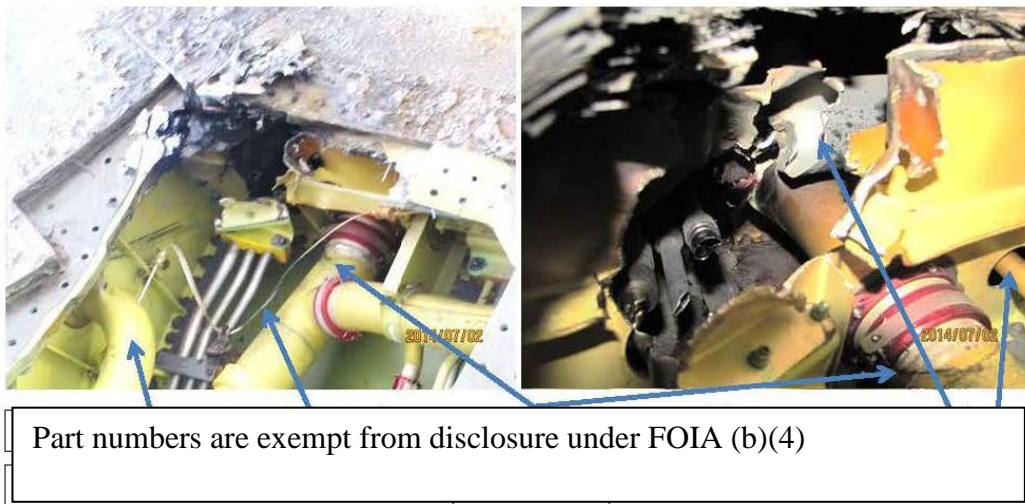
During the mishap, a fuel transfer tube, refuel tube and fuel siphon tube located over the engine in a fuel tank (Fig-9) were all partially or completely severed by the R3 integral arm ejection (Fig-10) (Tab J-152). During engine operation, the fuel transfer tube is pressurized. After being partially severed, this tube leaked a significant amount of pressurized fuel feeding the subsequent external and internal fires (Tabs J-7, J-8, J-62 thru 68).

Fig-10. Fuel system damage (Tab J-68)

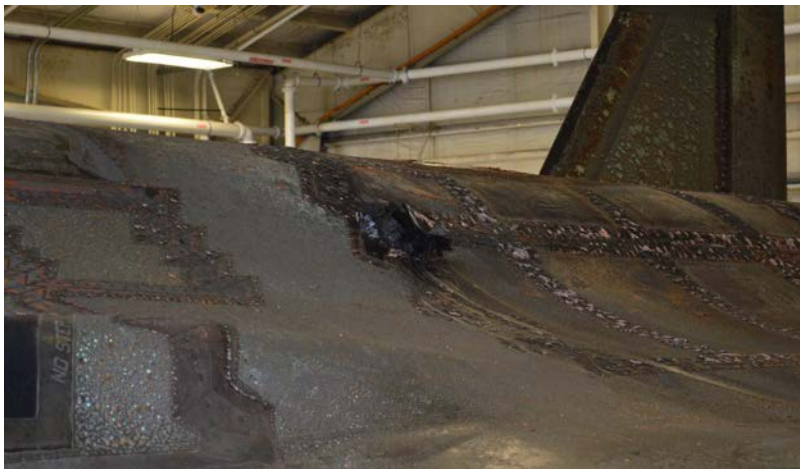
Fig-11. Hole in top of aircraft (Tab S-5)

A hole (10 x 7 inches) in Panel 3331 (top of fuselage) directly above and corresponding to the hole in the engine fan case was discovered post mishap with the composite plies/fibers splayed outward (Fig-11) (Tabs J-7 thru J-8). This panel covers parts of the fuel tank that was damaged and another fuel tank (Tab J-7). Three hydraulic lines and four fuel tubes (discussed in paragraph 6.a.(3) above) were damaged or severed at this location (Tabs J-61, J-68).

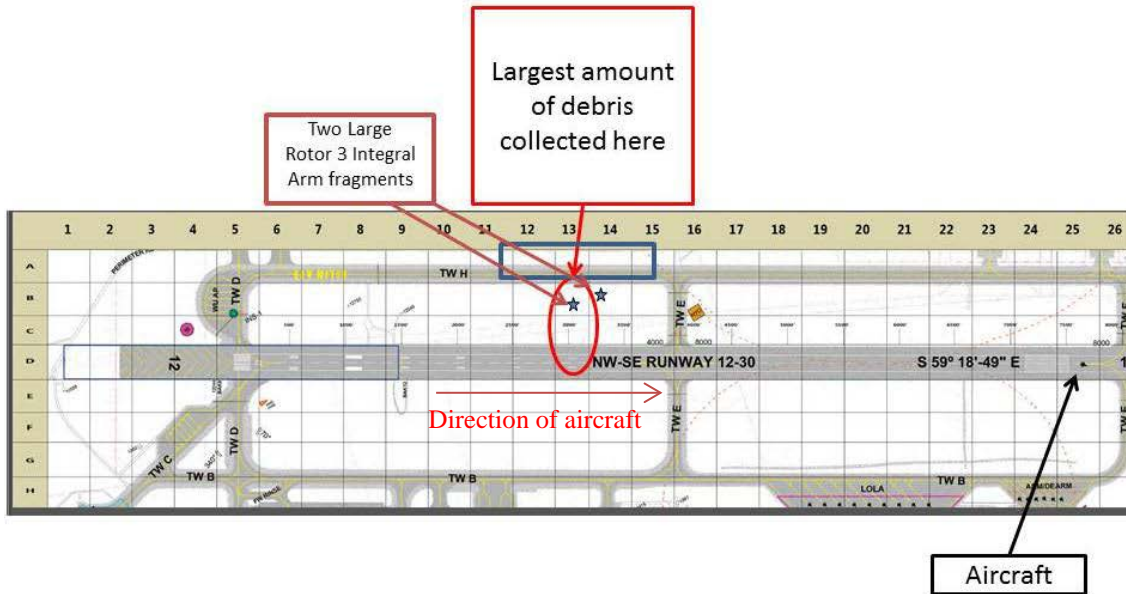
Engineering analysis by P&W and the JPO indicates that during the MA's takeoff roll at 0910L, the R3 forward integral arm catastrophically failed and liberated from the engine (Tab J-147). This failure immediately caused an engine stall as the MP began to rotate for takeoff (Tab J-148). The liberated pieces of the R3 forward integral arm subsequently punctured the engine fan case and ejected out of the top of the aircraft falling just north of the runway while the aircraft continued to roll down the runway and eventually stopped (Fig-12, Fig-13). Following the

Fig-12. Location of debris along runway (Tab S-9)

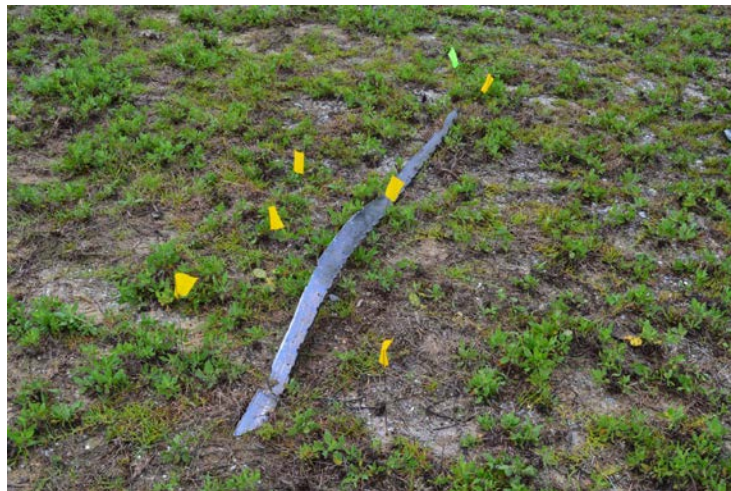
Fig-13. Fragment of R3 forward integral arm (Tab S-3)

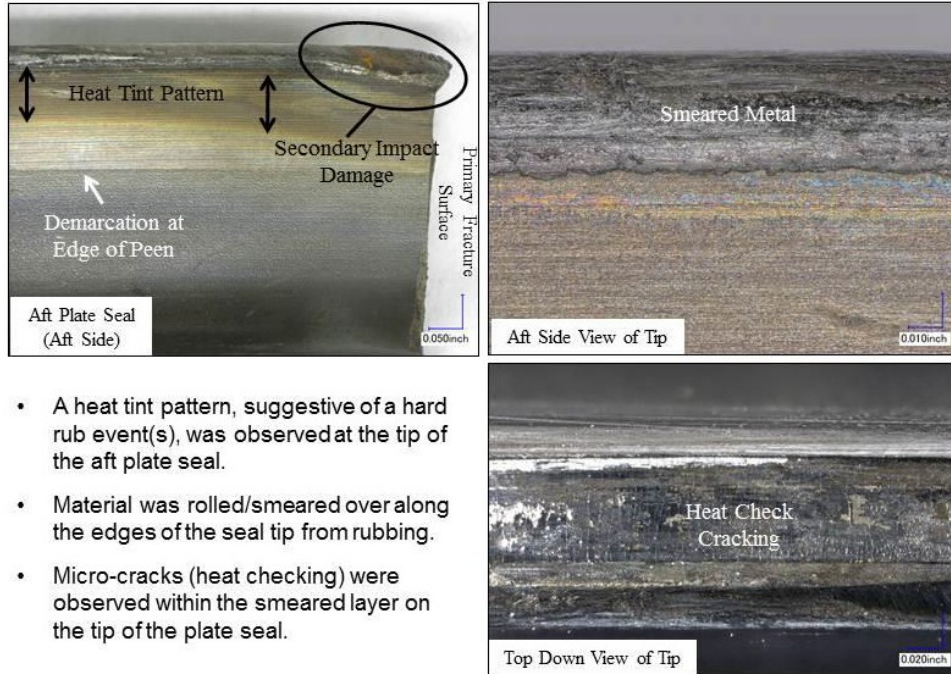
Evidence of the hard tip rub and subsequent extreme temperature included heat tinting, metal smearing and heat check cracking adjacent to the primary axial fracture location on the R3 aft (rear) plate seal (Tabs J-92 and J-166).

- A heat tint pattern, suggestive of a hard rub event(s), was observed at the tip of the aft plate seal.
- Material was rolled/smeared over along the edges of the seal tip from rubbing.
- Micro-cracks (heat checking) were observed within the smeared layer on the tip of the plate seal.

Fig-17. Heat Tinting, Metal Smearing, Micro-Cracks in Aft Plate Seal (Tab J-106)

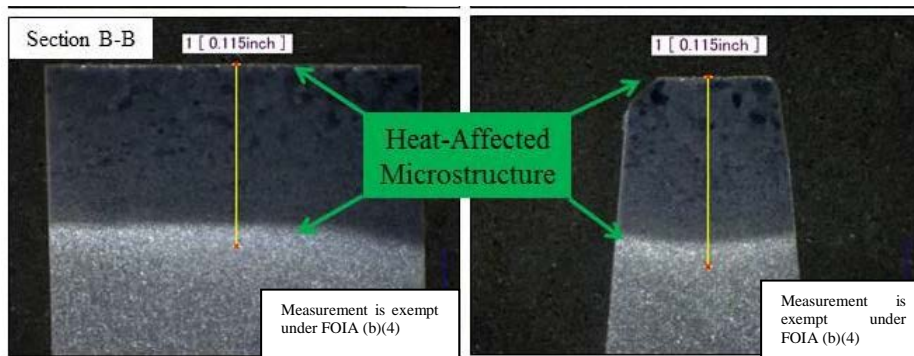
This heat damage from the hard tip rub induced a structural change in the composition of the microstructure and caused cracks to form in the R3 plate seal (Fig-17 thru Fig-20) (Tabs J-106, J-123). This heat damage can be seen in Fig-18 by the difference in color and texture.

Fig-18. Aft plate seal adjacent to fracture showing heat damage (Tab J-119)

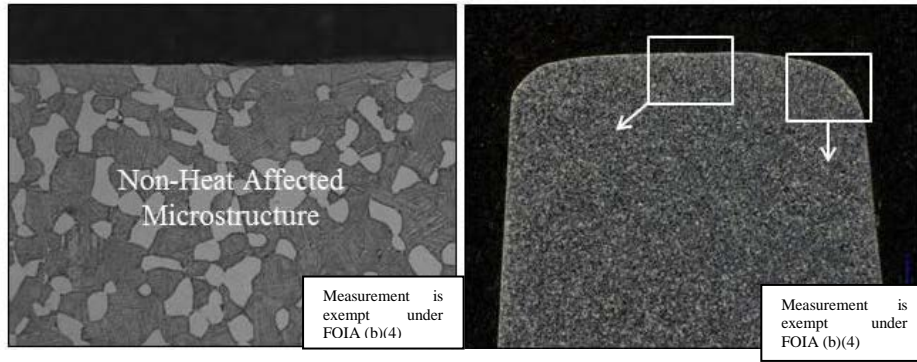
Fig-19. Aft Plate Seal 180 degrees from fracture location (Tab J-131)

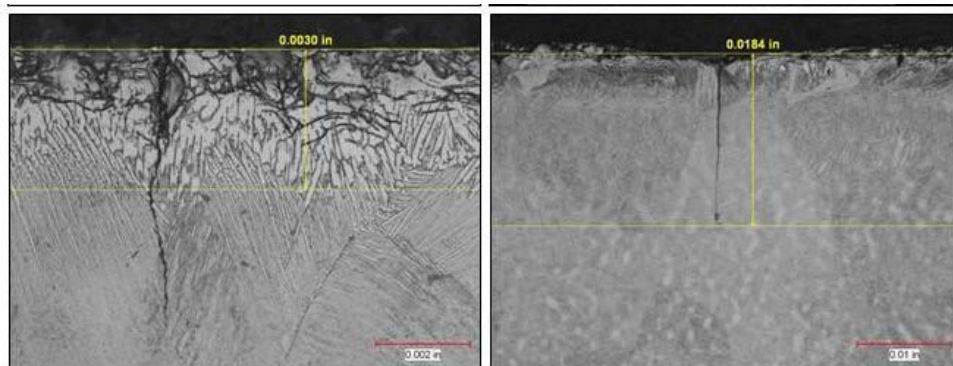
Micro-cracks formed on the aft plate seal of the R3 and extended radially further into the seal. These micro-cracks along the R3 plate seal eventually weakened the metal enough to allow a large axial fracture to develop, which became structurally unstable and led to the catastrophic material failure (Fig-20) (Tab J-93).

Fig-20. Radial cracks in heat affected microstructure extending .018 inch radially (Tab J-123)

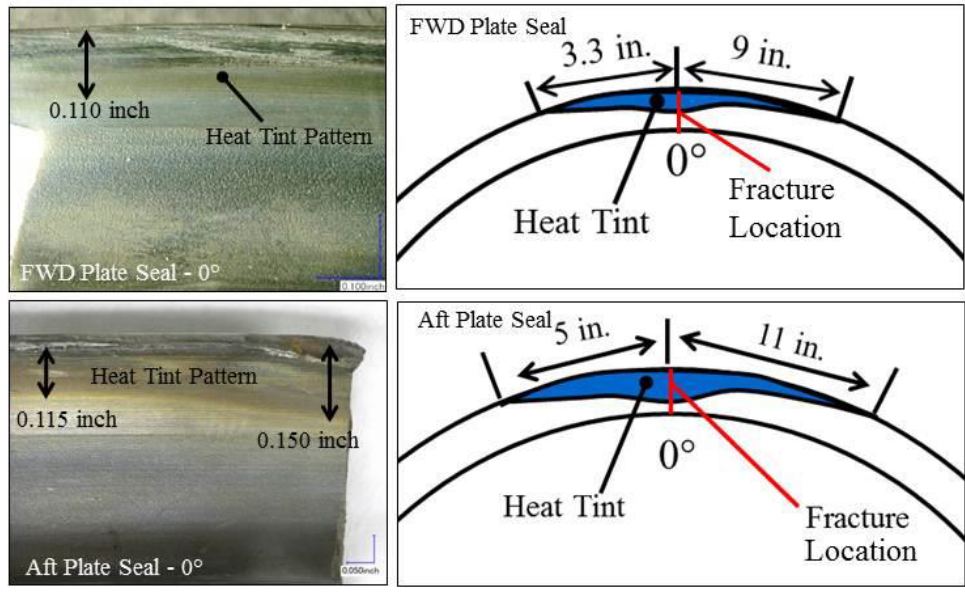
The extent of the heat tint pattern on both the forward and aft plate seals is depicted in Fig-21. The location of the eventual catastrophic fracture is depicted as the red line on top of the blue shaded heat tint area.

Fig-21. Total extent of heat tint damage (Tab J-139)

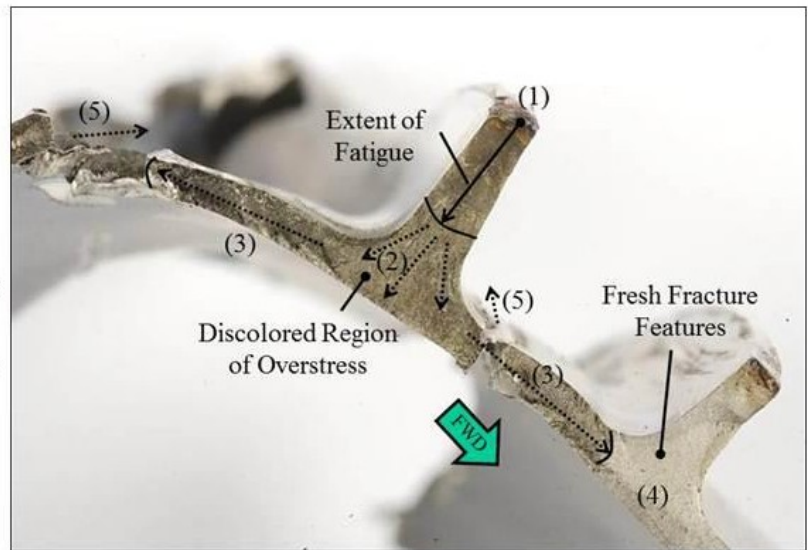
Fig-22. Fracture Sequence (Tab J-104)

Once the plate seals of the R3 were damaged by the hard tip rub event and subsequent heating, the micro-cracks began to expand into a larger fracture eventually leading to the ejection of the entire forward integral arm out of the aircraft (Fig-22) (Tabs J-92 thru J-93).

Fracture Sequence:

1. Fatigue progressed in the radial direction from the tip of the plate seal.
2. The crack continued in progressive tearing/overstress to the base of the plate seal and into the barrel of the integral arm.
3. The crack extended via progressive tearing in the axial direction forward and aft.
4. The final overstress fracture through the integral arm resulted in the loss of the hoop.
5. Circumferential overstress fractures occurred between the plate seals, and between the disk and forward integral arm.

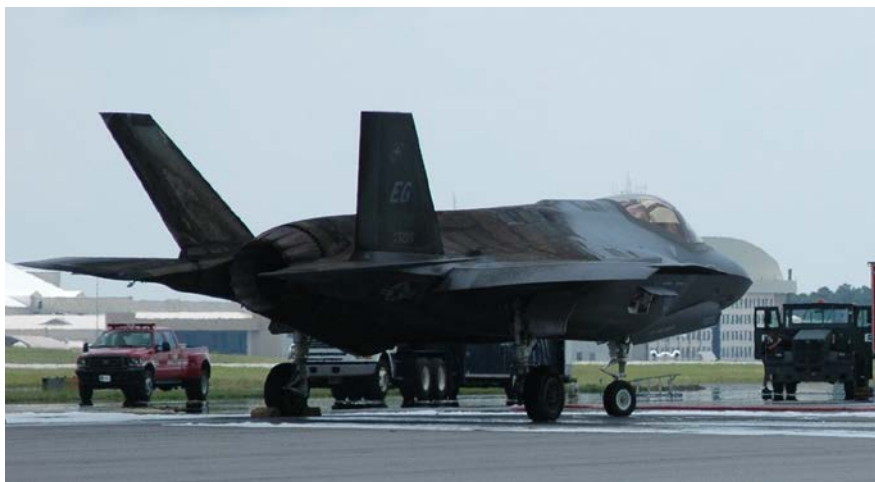
An exterior fire on the MA during takeoff roll was reported by multiple witnesses of the event (Tabs R-4, R-6, V-1.4). Aircraft sensors detected this fire during takeoff and was verified by extensive damage to the interior and exterior of the aircraft post-mishap (Tabs J-4 thru J-9).

Fig-23. Fire damage post mishap (Tab S-2)

Based on the evidence and their analysis, P&W and the JPO concluded that the initial fire started when the R3 forward integral arm fragments were liberated and punctured the engine fan case. These fragments traveled through a fuel tank severing multiple pressurized hydraulic lines and fuel tubes. These pressurized fluids then rapidly atomized as they exited the aircraft into the airstream. The catastrophic engine failure due to the R3 failure provided an ignition source for the fuel that was no longer contained within the fuel system. The fire, fueled by pressurized hydraulic fluid and JP-8, burned on the dorsal side of the aircraft fuselage, aft of the aerial refueling door (Tabs J-7 thru J-9).

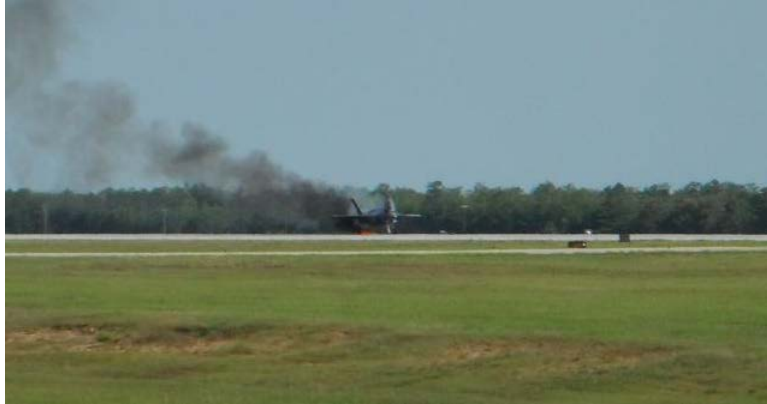
After the MP brought the MA to a stop on the runway and shut down the engine, pressurization to the fuel and hydraulics stopped as designed per JTD (Tab O-2). Photographic evidence shows the fire continued underneath the aircraft, fed by leaking fuel (Fig-24). At 09:13:55L, aircraft fire detectors reported a fire in the engine bay, likely due to the auto-ignition of leaking fuel in the engine bay from the heat of the ground fire. The Fire Chief reported the fire under control 7 minutes and 22 seconds after the initial engine stall was recorded on the MA CSMU (Tab J-5).

Fig-24. Ground fire post aircraft shutdown (Tab S-3)
