INTERIM ASSESSMENT:
2014 USS *HOUSTON* (CA-30) DIVEX

Prepared By:

Underwater Archaeology Branch
Naval History & Heritage Command
Department of the Navy

July 25, 2014

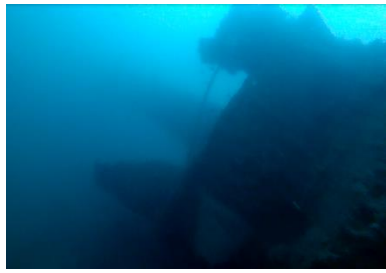
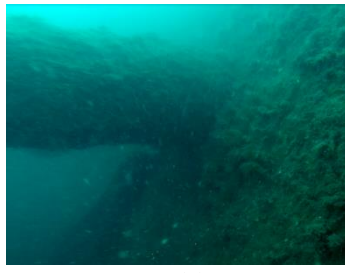
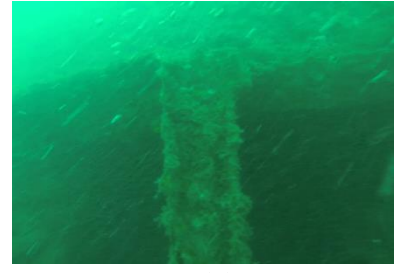
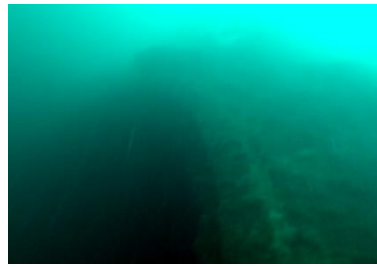
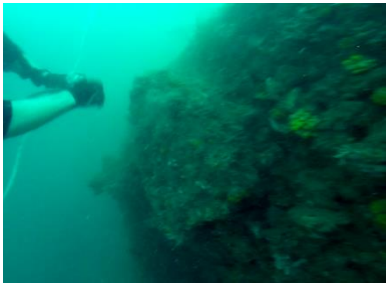
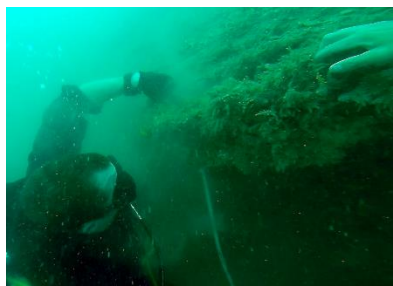
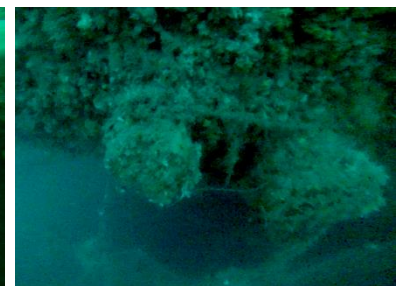
The original construction plans for USS *Houston*, preserved in the National Archives RG 19, were located and provided a basis for comparison of site features identified via video recordings. As aforementioned, some of the most characteristic areas of USS *Houston*, such as the bow rake, stacks, masts, and gun turrets, were significantly damaged and dislocated during the battle and/or ensuing wrecking event. Furthermore, marine growth and an expansive array of nets blanket the site and conceal many of the finer telling features. Complicating the assessment is the fact that the DIVEX timetable did not permit for the establishment of any form of reference grid that would permit for the precise positioning of identifiable features. Nevertheless, a number of observations favor the identification of the vessel as USS *Houston*, the most prominent of which include the main tripod mast tops of USS *Houston* (Fig. 6 (A)) and port mast stump (Fig. 6 (B)), a dual hatchway amidships beneath the airplane catapults (Fig. 6 (C)), the vessel's three observed gun turret casings (Fig. 6 (D, E, F)), and the positioning of cleats and chocks in the stern (Fig. 6 (G, H, I)). Tellingly, no observed features were inconsistent with such an identification; however, the significant damage observed on site may have concealed such markers.

Figure 6: Screen shots (A-I) from GoPro video of identifiable features, as well as their locations relative to the original plan of USS *Houston*, presented here in top-down view as the hull presently rests on the seafloor.

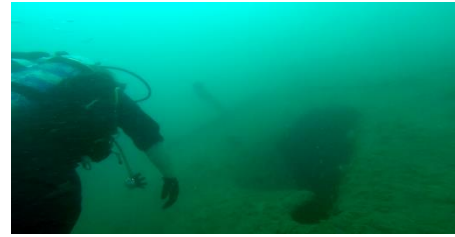
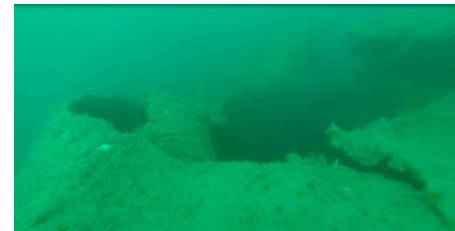
The wrecked vessel is marred by evidence of battle damage in the form of areas of deformed hull, as well as penetrations of the hull and decks that exhibit outward-forcing damage, the result of shell explosions. Additionally, the vessel clearly also suffered damage as a consequence of its wrecking event, which resulted in all three main gun turrets being dislodged, the main mast and associated superstructure being displaced, the stacks being displaced, and the aft mast leaving little trace. There is, however, particular evidence of battle damage that corresponds directly with eyewitness accounts of damage suffered by USS *Houston* (e.g. Holbrook 1981:83-102). Among them is an account of a shell penetrating the wardroom (Fig. 7 (A)), which correlates with corresponding damage on the exposed port side of the vessel, a possible torpedo hit on the port side amidships (Fig. 7 (B)), as well as horrendous damage at the deck/side interface between the stern stack and aft mast (Fig. 7 (C)).

Figure 7: Screen shots (A-C) of GoPro video documenting battle damage, as well as their locations relative to the original plan of USS *Houston*, presented here in top-down view as the hull presently rests on the seafloor.

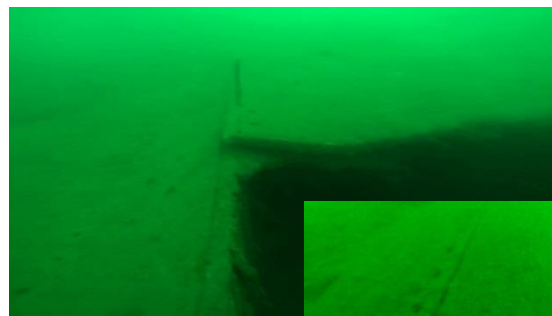
Fig. 9

Rivets running along the sides of seams that hold hull plates together have been systematically removed to allow for the plates to be lifted as part of unauthorized recovery operations. Figure (9) shows a gap where a plate has already been removed and the initial lifting of the subsequent plate. The marker standing upright in the center of the image is placed on the last rivet that has been removed along the seam. Figure (10) shows a seam between metal hull plates with rivets removed. Sequential removal of rivets was observed in multiple areas of the exposed port side of the hull.

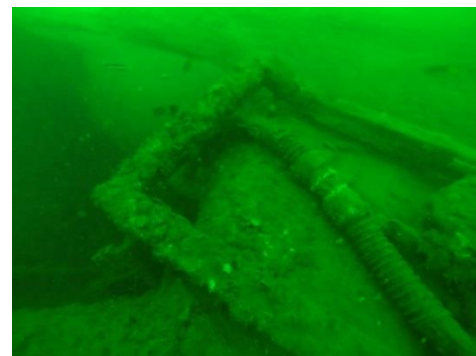
Fig. 11

The deck of the wrecked vessel has caved in or been deformed by extensive battle-related damage. Figure (11) shows what appears to be a water-dredge, used to remove sediment from an underwater environment, adjacent to such a cavity that permits entrance to the interior of the hull. Dredges of this type are commonly utilized in salvage or archaeological operations to excavate through sediment. The condition of the dredge indicates it has been present on site for some time, while it is still being weighed down by a rectangular metal frame, suggesting continued use.

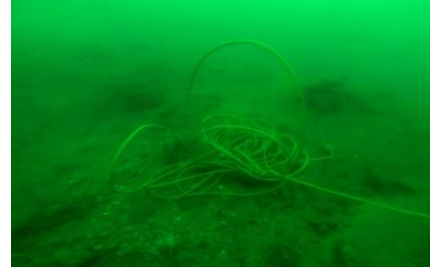
Fig. 12

A modern hollow hose was observed coiled near the stern on the exposed port side of the vessel (Fig. 12). The hose's loose end was not traced. It is apparently consistent with the type of rudimentary surface-supplied diving system that local divers might use to support prolonged operations through pumping compressed air down to the seafloor for breathing purposes.

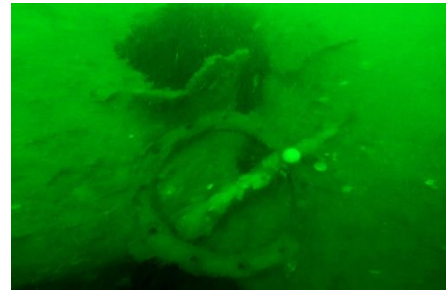
Fig. 13

The vast majority of portholes observed by divers on the exposed port side of the hull have been removed; what remains is typically evidence of forceful removal in the form of a circular gap in the hull. Figure (13) shows a custom-made tool constructed for such a purpose of forceful removal, alongside a rubber gasket that once formed part of a porthole seal, as well as a disfigured porthole nearby. Divers observed that the tool utilized a handle made of a golf ball.

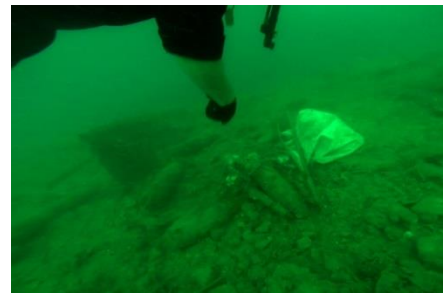
Fig. 14

Resting on the exposed port side of the hull, divers observed an accumulation of shells and ordnance, alongside a canvas bag, placed there in preparation for their recovery (Fig.14). Given the location of the ordnance, this is not deemed to be a natural accumulation, but rather evidence of the unauthorized removal of (live) ordnance from the site. Potential casings, shells and UXO is evident in moderate quantities in several locations across the site.

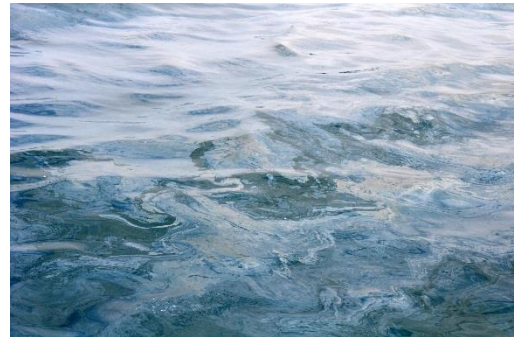
The presence of oil slicks on the surface of the water above and around the DIVEX site was noted by multiple project participants and observed in several locations scattered several hundred feet apart over the vessel. The first evidence of oil in the water column was recorded by the side-scan sonar team as the towfish was being recovered on 10 June. Subsequently, slicks and active seeps were witnessed during the mornings of 11, 12, and 13 June when the sea surface was calm. Figure (16) shows a moderately-sized slick that accumulated in the vicinity of USNS *Safeguard*. Figure (17) shows a small oil seep as the oil reaches the water's surface and expands, forming a small sheen.

Fig. 16: Oil slick concentrated over the DIVEX area of operations.

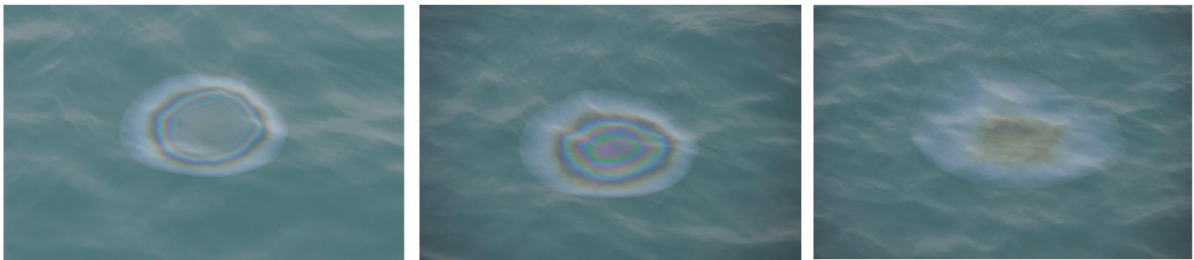
Fig. 17: Three images documenting a small oil seep over the DIVEX target rising to the surface and dispersing to form a small sheen.
