OPERATIONAL TEST AND EVALUATION

SUBJECT: Follow-on Operational Test and Evaluation (FOT&E) Report on the Joint High Speed Vessel (JHSV)

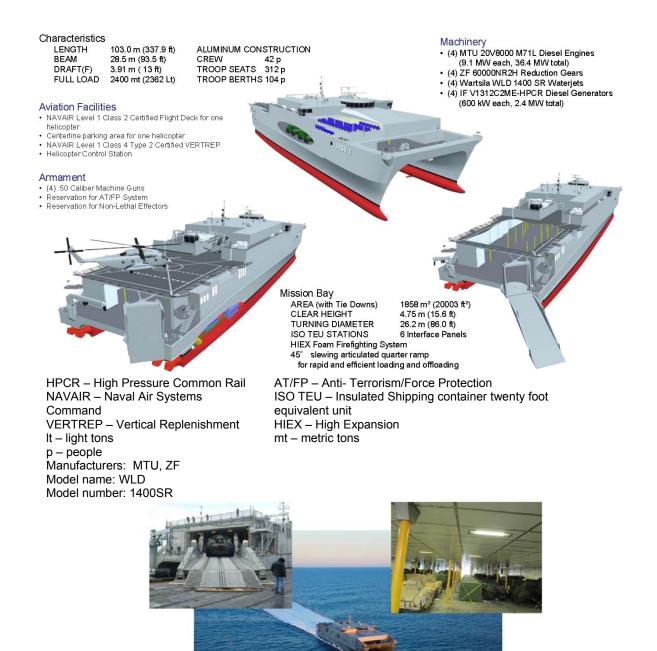
Figure 2. Joint High Speed Vessel (JHSV)

JHSV is a high-speed, shallow-draft surface vessel designed for intra-theater transport of personnel and medium payloads for the Joint Force, as shown in Figure 2. It is a redesign of a commercial catamaran capable of accessing relatively austere ports. JHSV can support an embarked force of 104 personnel for up to 14 days or a larger force of 312 personnel for 4 days. JHSV has a large mission bay accessible from piers or floating causeways via an integrated, stern-mounted ramp. The ramp and mission bay can accommodate both wheeled and tracked vehicles up to and including a combat-loaded M1A2 battle tank. The mission bay also can host 20-foot equivalent containers, including those that require power and data connections. JHSV has a flight deck that can support landing, fueling, and power requirements for various unarmed Navy helicopters up to and including the MH-53E. JHSV is also equipped with a stern-mounted crane used in this testing to launch the SDV, but is also capable of launching boats such as an 11-meter Rigid Hull Inflatable Boat through Sea State 2.

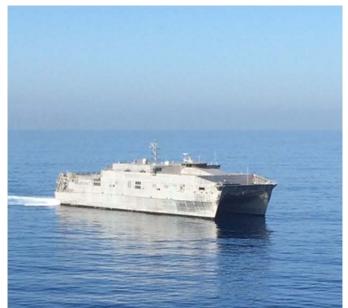
Figure 3. USNS Millinocket (JHSV-3) in Sea State 3 Conditions near Camp Pendleton

Figure 3 shows USNS *Millinocket* the day of the second test in Sea State 3 conditions. The seas in Figure 2 look very calm, but data from the nearby National Oceanic and Atmospheric Administration buoy indicated a swell from the south with significant wave height of $2\frac{1}{2}$ feet (0.7 meters) and a $12\frac{1}{2}$ -second period, which technically meets the North Atlantic Treaty Organization Sea State definition for Sea State 3.

Although the seas in the lee of MLP (CCS) (an area sheltered from the wind and waves), where JHSV was moored, were estimated to be Sea State 1 to 2, the vehicle transfer test failed. Figure 4 shows the two ships moored skin-to-skin with the JHSV ramp deployed. The hydraulic ram used to swing the ramp port to starboard tore free from its anchor point on the JHSV transom. The small amount of movement between the ships, even in calm Sea State 1 to 2 conditions, was enough to cause the damage when a truck pinned the foot of the ramp onto the raised vehicle deck of MLP (CCS) as it transited the ramp. The physical strength of the ramp was not compromised; the Marine Corps truck returned to JHSV, but this ended the vehicle transfer portion of the test. The Navy has not made any design changes to the JHSV ramp to enable these transfers. JHSV is not effective for operations with MLP (CCS) unless in Sea State 1 conditions, which is an unacceptable constraint for operational deployment.

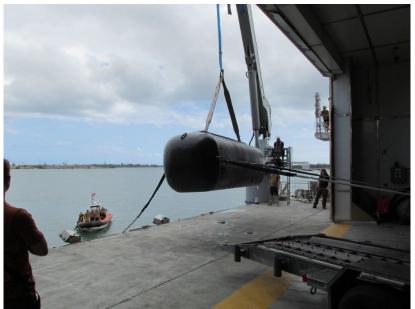
Figure 5. SDV Suspended While Trailer is Removed

The launch of the SDV is deceptively simple. Figures 5 and 6 show the SDV after it was lifted from the trailer during a pier-side test, and just before it was placed in the water during an underway test.

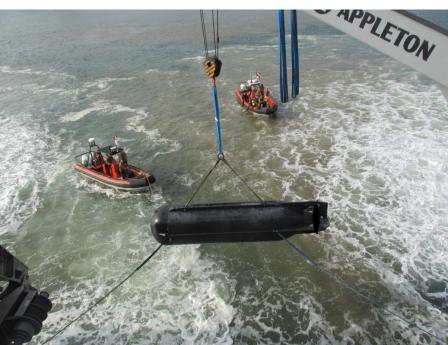
Figure 6. SDV Being Placed in the Water

Figure 6 illustrates several points of interest in the SDV launch. Two tending lines, one attached at the front and the other at the back of the SDV, extend to personnel on JHSV. A third line attached at the front of the SDV is secured to a support boat. The second boat shown in the figure has Navy Special forces swimmers and divers. Turbulent water, from the JHSV waterjets, is also clearly shown in the Figure 6. Prior to swimmers and divers entering the water, the JHSV crew declutches the engines from the waterjets (they put the ship in neutral). This clears the

Two other items of concern uncovered by this test are the vulnerability of the SDV to a pendulum swing motion while suspended by the crane, and the possible effects on SDV operators and passengers from JHSV engine exhaust. While suspended, the SDV was vulnerable to pendulum motions during both the open-ocean launch and recovery of the SDV events, and the tending line personnel were challenged to control this. As noted, the significant wave height indicated Sea State 3 conditions during the open-ocean portion of the test. As shown previously in Table 2, the open-ocean launch time, from lifting the SDV from the trailer, launching it, and then clutching in the JHSV engines, took 3 minutes. As shown previously in Table 3, the recovery from declutching engines to placement of the SDV in the trailer cradle took 16 minutes. The extended recovery time was due to the challenges the line tenders experienced controlling the pendulum motions of the SDV. A mitigating factor for actual missions may be, by default, a Sea State 2 limitation. The support boats for this test operated from shore, but in actual operations, the boats would be launched by JHSV prior to launching of the SDV. JHSV's IOT&E demonstrated that launch or recovery of these type boats was limited to Sea State 2. At Sea State 2, the pendulum motions of the SDV should be less. Alternatively, the crane could be upgraded with a pendulation control system.

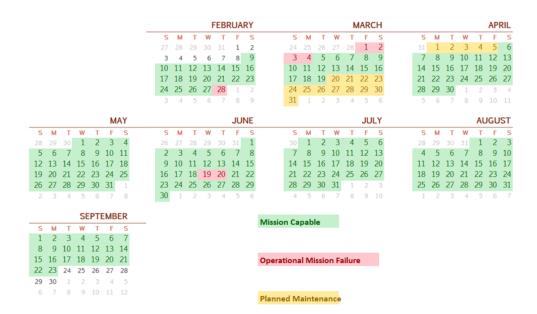
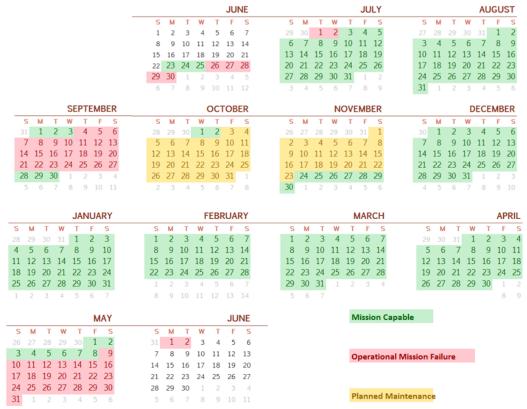
Figure 7. USNS Spearhead Availability during Test Periods

JHSV Availability during IOT&E, February 9 – September 23, 2013

JHSV Availability during FOT&E, June 23, 2014 – June 2, 2015

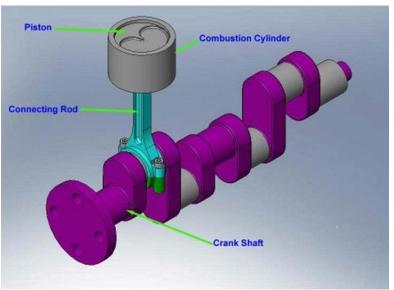
Figure 8. Piston, Connecting Rod, Crank Shaft

Connecting rods that connect the reciprocating pistons to the crank shaft (Figure 8) have failed in SSDGs installed in the JHSV ship class. Currently, all new and rebuilt Fincantieri-manufactured SSDGs are being fitted with a third-generation connecting rod, including a rebuilt of # 4 SSDG on USNS *Spearhead*.

- Continue aggressively determining the root cause of ship service diesel generator casualties and fixing them fleet-wide.
- Evaluate whether repairs and alterations to the waterjet reversing buckets, along with alterations to the ship autopilot system, resolve the failure mode of this equipment, or, alternately, investigate a replacement schedule to minimize waterjet casualty downtime.
- Evaluate whether the repairs and alterations to the internal operating mechanism of the forward ride control foils resolves the failure mode.
- Complete structural reinforcement of bow structure on remaining ships of the class.

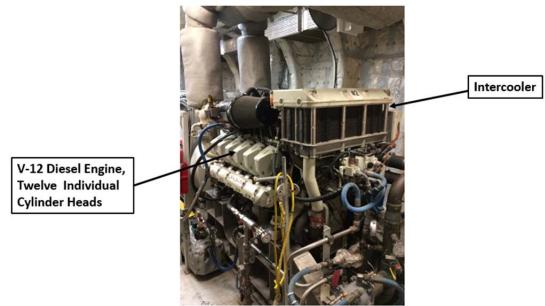
Figure 9. SSDG Number 2, USNS Spearhead

The SSDGs are turbocharged, relying on seawater-cooled intercoolers that have been leaking (Figure 9). Internal combustion engine power output is largely determined by the displacement of the cylinders. A normally aspirated engine relies on ambient air pressure to fill the cylinders with air and the fuel is added in proportion to the amount of air. Turbochargers, powered by exhaust gas from the running engine, are used to compress incoming combustion air so that more fuel can be injected and power output is increased. All turbocharged engines have an intercooler that cools the air after it is compressed and before combustion. For these engines,

the working fluid for the intercoolers is seawater. All four intercoolers had seawater leaks during this test period. USNS *Spearhead's* SSDGs suffered heavy piston and valve train damage, likely a result of corrosion from exposure to seawater.

Many of the individual cylinder heads (Figure 9) of the Fincantieri-manufactured SSDGs have developed cracks that allow engine coolant to leak into the cylinders. Each cylinder head contains four valves, two for fuel/air intake and two for exhaust. Manufacturing issues, both in head castings and assembly, are the cause for erosion and cracking of the heads. All 12 heads were replaced on two of four USNS *Spearhead* SSDGs during this test period. Figure 10 shows the flame face surface of one cylinder head and the close up of another cylinder head showing erosion. The same cylinder head in the close up has been sectioned to show an intake port in Figure 11. The right hand picture in Figure 11 shows a Magnaflux inspection that verifies the location of a crack in the intake bridge.

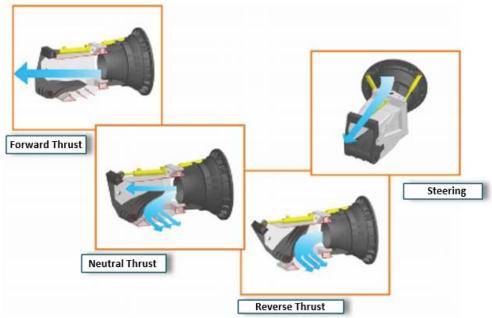
Figure 12. Ship Waterjet Positions for Various Directional Thrusts

All four waterjets suffered broken or failing reversing plates. The reversing plates are used to redirect the waterjet outlet flow to allow neutral thrust or reverse propulsion (Figure 12). An analysis by the waterjet manufacturer suggests the failure of the reversing plates was due to high-cycle, low-load, bending fatigue.⁵ A sideways loading is suspected to have caused the failures. When not positioned for neutral or reverse propulsion, the plate stiffeners interact with the water flow as the ship is moving forward in the water. As shown in Figure 12 below, the waterjet is set for forward thrust and the underside of the reversing plate is exposed to water flow proportional to the ship's speed through the water. In Figure 13, the modeled reversing plate shows three plate stiffeners that are highlighted in red. The loading that is suspected to have caused the failures is caused by a sideways force on these plate stiffeners. Modifications have been made to the reversing plates to lessen the sideways force by as much as two-thirds. Additionally the weld around the lower support tube in Figure 14 has been machined to a smooth surface so that the stresses are not amplified by small fluctuations of the weld surface. Figure 15 shows close ups of this weld. The autopilot control has been modified to lessen the cycling of the jets side to side as the ship maintains heading, which is intended to reduce the number of load cycles and further delay the initiation of any fatigue cracks.

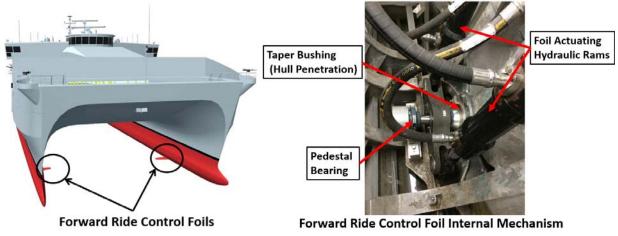
Figure 16. JHSV Forward Ride Control System (RCS)

The USNS *Spearhead* RCS has suffered failures of the internal mechanism for the forward foils. The JHSV ship class uses a RCS that provides active pitch/roll damping using four control surfaces, two forward and two aft. The system is designed to not only smooth out the ride, but to limit structural loading on the ship bow. It is required to be operational for ship speeds greater than 15 knots. Even with the RCS operating, the ship is limited in speed through the water both by sea state and orientation of the seas. Figure 16shows the location of the two forward ride control foils and the internal mechanism for one of these that holds the foil in place and positions it. The aft RCS consists of two hydraulically actuated, horizontal foils that interact

with the flow of water passing under the ship in the vicinity of both the port and starboard waterjets.

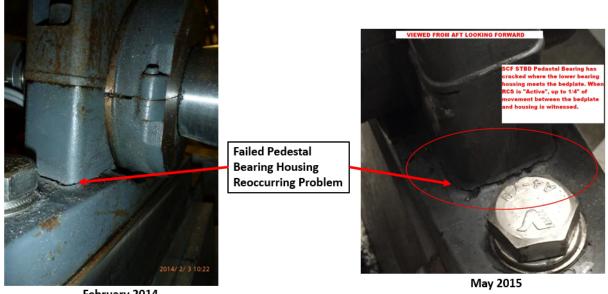
Figure 17. Failed Pedestal Bearing Housing

Several structural issues with the RCS forward foil mechanism have required repairs. Figure 17 shows failed pedestal bearing housings from 2014 and 2015. Alignment problems have prompted machining, shimming, and re-boring of holes for the base bolts of this bearing structure. The taper bushing assembly shown in Figure 16 has also drawn concern both for fit of the pieces and under-torque of the bolts holding it in place.

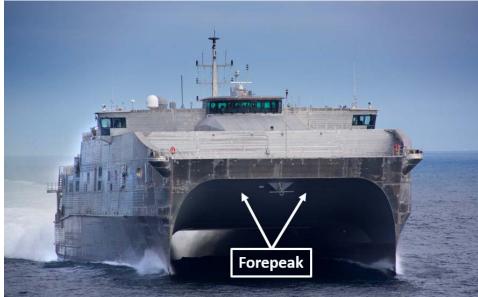
Figure 18. JHSV Forepeak

The entire ship class requires reinforcing structure for the bow structure in the forepeak space, which is the forward structure of the ship between the two hulls, as shown in Figure 18. The American Bureau of Shipping originally recommended that the bow structure in the

forepeak area be built to withstand 26.1 pounds per square (psi) loading caused by wave slamming. The ship manufacturer, Austal USA, proposed a revised Safe Operating Envelope (SOE) to eliminate the likelihood of head seas and recommended a design to withstand pressures up to only 17 psi. The ship design manager approved the Austal USA proposal and the Navy Program Manager concurred.

Hulls 1 through 4 have been repaired and reinforced, adding an additional 1,736 pounds to the ship's weight. This should have minimal impact to ship mission capability in regards to fully loaded range capability. From the IOT&E report, when the ship is fully loaded with troops and equipment (600 short tons), the ship's fuel tanks cannot be completely filled with fuel. The additional weight from the added bow structure displaces 250 gallons of fuel, which correlates to 3.5 nautical miles of reduced range at 31 knots (reduced to 854 nautical miles).

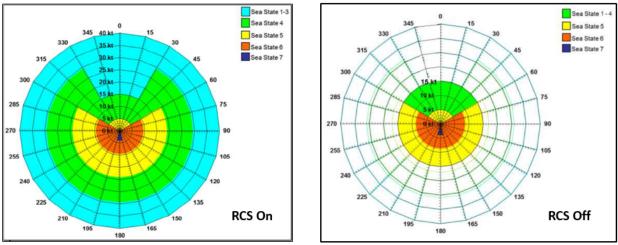
Figure 19. JHSV Ship Class Safe Operating Envelope (SOE)

The RCS failures are a symptom of a more serious problem with the JHSV bow structure related to the ship's Safe Operating Envelope (SOE), which is designed to limit wave impact loads on the bow structure. There are two SOEs: a less restrictive SOE, used with a functional RCS, and a very restrictive SOE used when the RCS is broken or turned off. Compromises in the bow structure, presumably to save weight, were accepted when building these ships. Multiple ships of the class have suffered damage to the bow structure, and repairs/reinforcements are in progress class-wide. The reinforcement of the bow structure does not expand the SOE, but should allow full use of the ship, within the original SOE, without risk of damage. Hulls 1 through 4 are being repaired and reinforced, adding an additional 1,736 pounds to the ship's weight. This should have minimal impact to ship mission capability in regards to fully loaded range capability. From the IOT&E report, when the ship is fully loaded with troops and equipment (600 short tons), the ship's fuel tanks cannot be completely filled with fuel. The additional weight from the added bow structure displaces 250 gallons of fuel, which correlates to reducing the ship's range by only 3.5 nautical miles at 31 knots (reduced to 854 nautical miles).

The decision to accept a limiting SOE and build the ships to withstand only 17 psi loading from wave slamming has resulted in a ship class that is easily damaged. The SOE defines allowable speeds in varying sea states and angle of wave motion to ship's heading. Figure 19 shows the ship class SOE with and without an operational RCS. Operating the ship outside of the SOE or encountering a rogue wave that is outside of the current sea state can result in sea slam events that cause structural damage to the bow structure of the ship. Figure 20 shows internal bent scantlings in the forepeak area of JHSV 1.

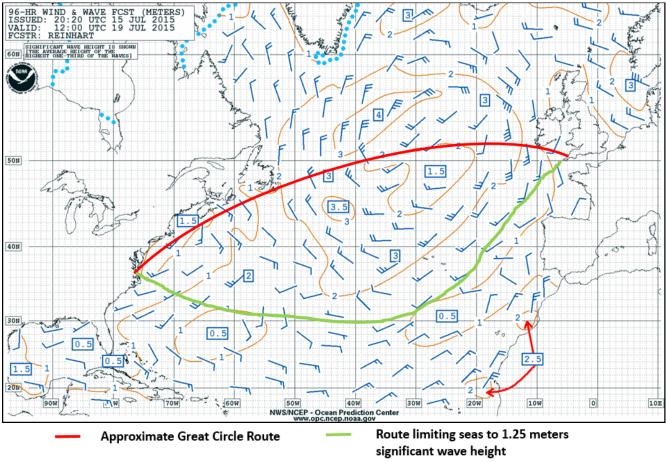
Figure 21. Routes across the Atlantic

The necessity of avoiding high sea states while transiting is a potential operational limitation that was not examined in the IOT&E report. At wave heights of 2 meters, the ship needs to slow to 15 knots or less, and at 3 meters, the ship can transit at only 5 knots or less. Figure 21 is a 96-hour wind/wave forecast for the Atlantic Ocean from July 15 - 19, 2015, from the National Oceanic and Atmospheric Agency. The red arc is an approximate great circle route, (shortest distance) between Virginia and England. Of note are the wave heights along this route, ranging from 1 meter to 3 meters. The green route adds a significant distance to the transit but keeps to seas with significant wave heights of 1.25 meters or less (Sea State 3 and below) and allows higher transit speeds while staying within the SOE for the ship. These sea state limitations are always a concern for this ship.
