UNITED STATES AIR FORCE
AIRCRAFT ACCIDENT INVESTIGATION
BOARD REPORT

F-35A, T/N 10-5015

58TH FIGHTER SQUADRON
33D FIGHTER WING
EGLIN AIR FORCE BASE, FLORIDA

DATE OF ACCIDENT: 23 JUNE 2014

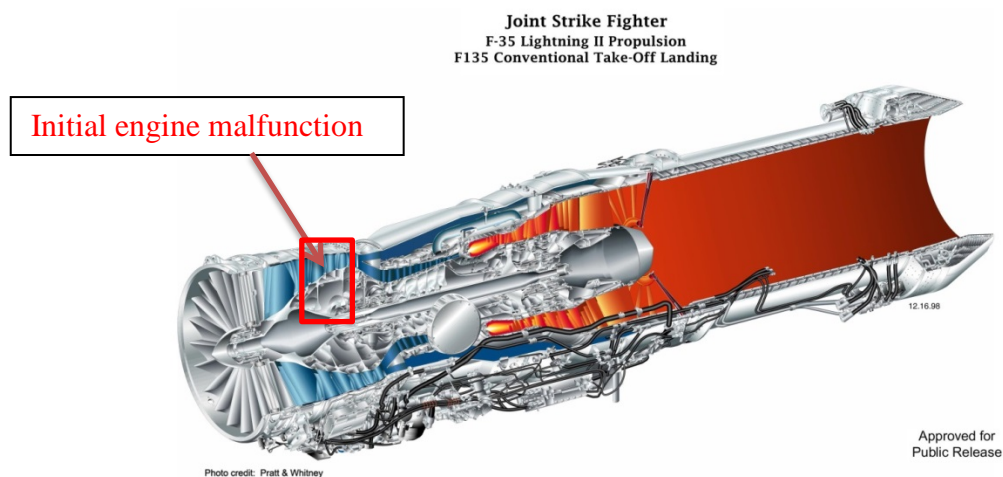
Fig-1. F135 Engine (red arrows/words added by AIB) (Tab Z-5)

Tear down and analysis performed by maintenance personnel from the 33 FW and P&W indicated the initial engine malfunction occurred inside the fan module of the MA's engine, which is the forward-most section of the engine (Fig-1). The fan module consists of inlet guide vanes and three stages of fan rotors. The third stage rotor is commonly referred to as R3. A pair of plate seals encircles the forward integral arm of the third stage rotor (Fig-2). A foam strip mounted to the second stage stators aligns with the seals to improve airflow efficiency in the fan section (Fig-2). Stators are stationary pieces affixed to the outer engine casing that encircle the integral arm seals to improve airflow efficiency.
